INDOOR AIR QUALITY ASSESSMENT

**Bradstreet School
70 Main Street
North Andover, Massachusetts**

Prepared by:
Massachusetts Department of Public Health
Bureau of Environmental Health Assessment
June, 2002

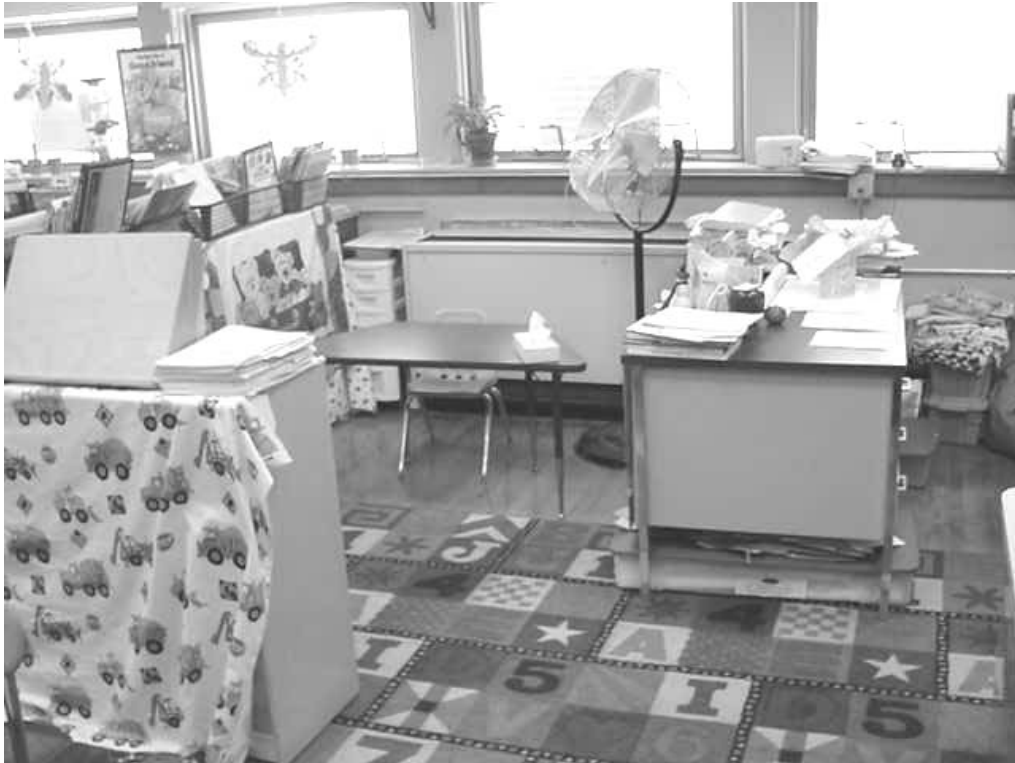
Picture 4

It can be seen from the tables that the carbon dioxide levels were below 800 parts per million (ppm) in all areas surveyed, with one exception, indicating adequate air exchange by the ventilation system in most areas. Fresh air in classrooms is supplied by a unit ventilator (univent) system (see Picture 2). Univents draw air from outdoors through a fresh air intake located on the exterior walls of the building (see Picture 3) and return air through an air intake located at the base of each unit (see [Figure 1](#)). Fresh and return air are mixed, filtered, heated and provided to classrooms through a fresh air diffuser located in the top of the unit. All univents were operable during the assessment. Obstructions to airflow, such as items placed in front of univent returns, were seen in a few classrooms (see Picture 4). To function as designed, univents and univent returns must remain free of obstructions.

Univent Airflow Obstructed by Classroom Furniture

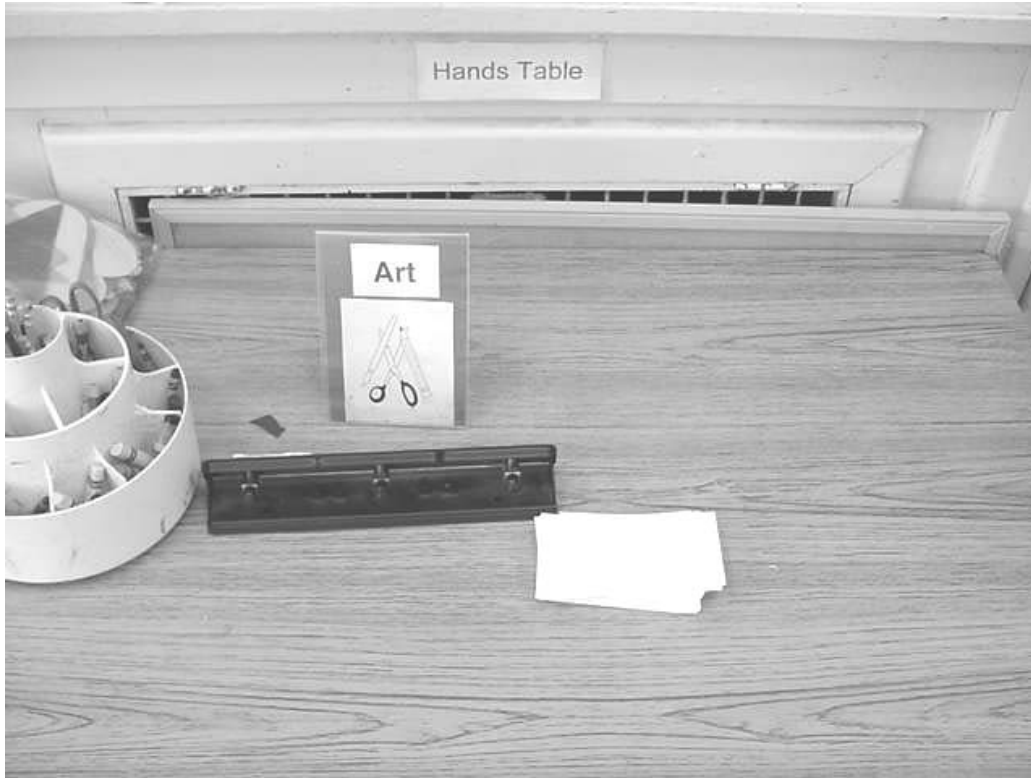
Picture 7

Mechanical exhaust ventilation is provided by wall-mounted intake grills connected to chimneys capped with exhaust fans (see Pictures 5 & 6). All exhaust vents were operating during the assessment. As with the univents, a number of exhaust vents were obstructed by tables, chairs, boxes and other items (see Picture 7).

Exhaust Grate Obstructed by Classroom Furniture

11. Clean univent return vents and exhaust vents periodically of accumulated dust.

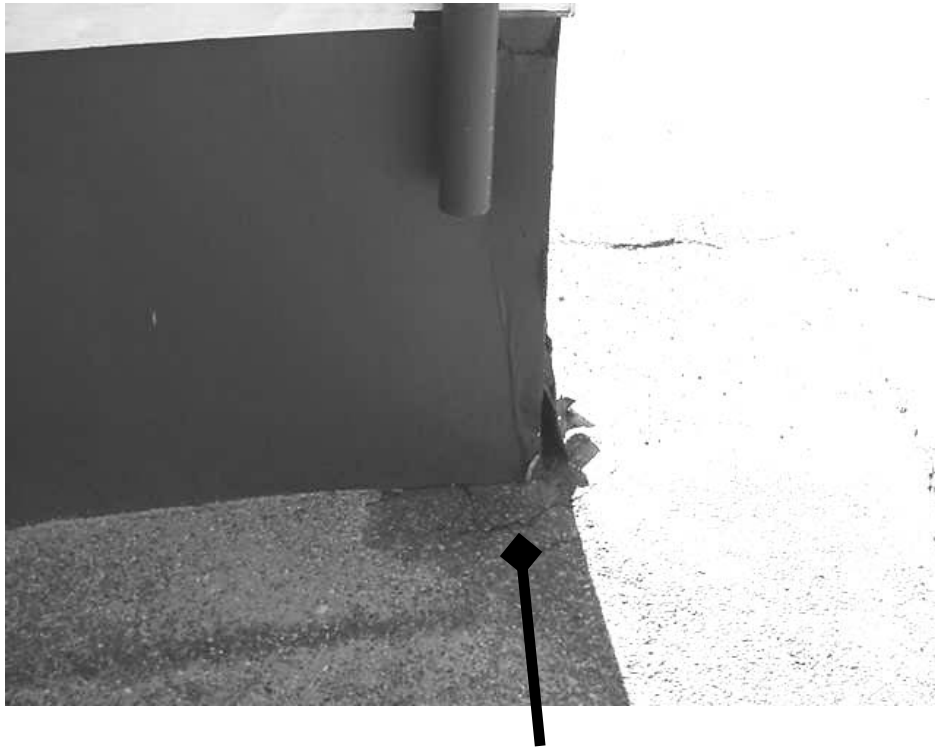
Picture 8

The exterior walls of the rear modular unit appeared to be intact. Drainage for this unit appears to be adequate. A downspout and gutter system exists for portions of this unit, which can allow for water on the roof to splash on the tarmac and wet the exterior wall of the modular in several areas. In addition, one of the downspouts ends several inches above the ground, which can allow water to accumulate near the exterior wall of the modular (see Picture 8). Under these circumstances, continued water exposure to the exterior walls may result in damage to the modular building in the future. There are minimal means for ventilating the crawlspace under this structure.

Downspout for Modular Classroom – Note Water Damage from Splashing

1. Consider installing gutters/downspouts in areas without them to drain water from the roof. This will allow the delivery of water to the tarmac in a manner which prevents splashing or moistening of the exterior wall. Extending downspouts to ground level to direct water away from the base of the exterior wall of the modular classroom is also advised.
2. Improve ventilation of crawlspace beneath modular unit by installing large passive air vents. If this is done, ensure that the underflooring is sufficiently insulated.

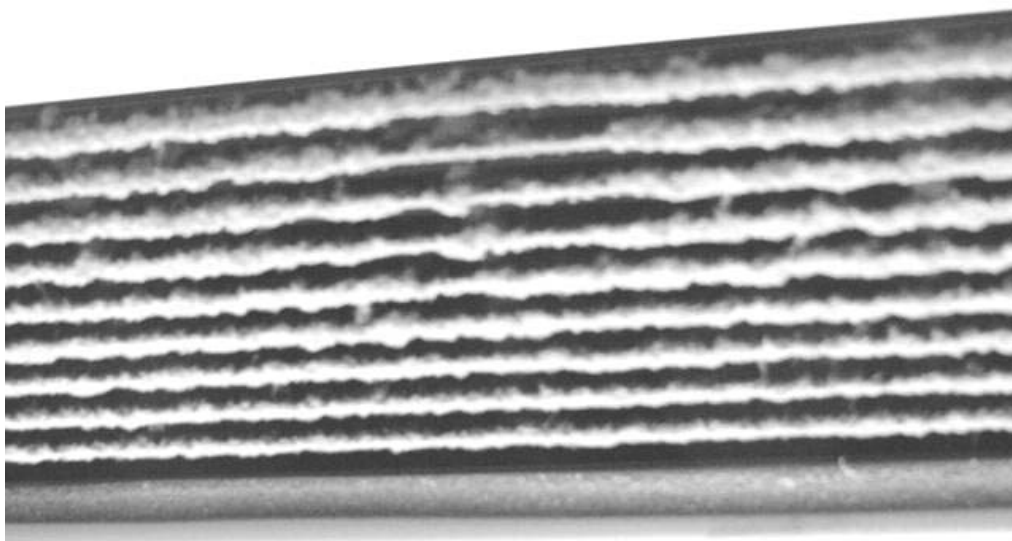
Picture 9

Accumulated Dust on Univent Return Vent

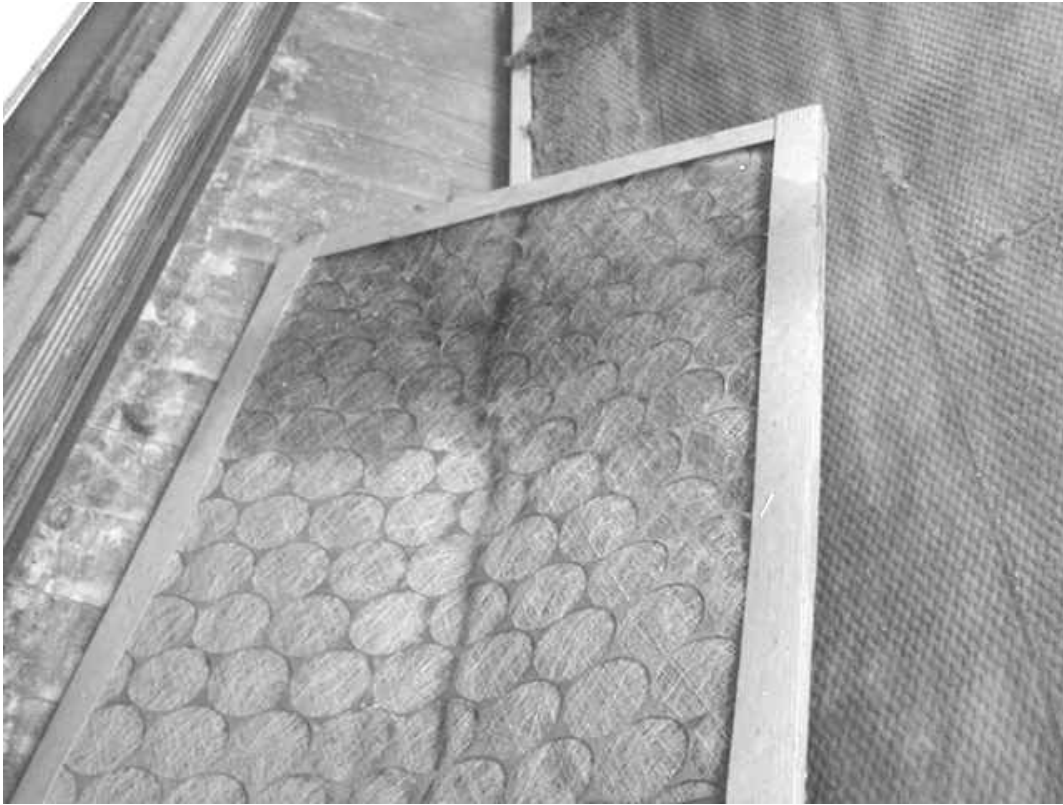
Picture 10

The univent in classroom 10 was opened to examine the conditions of filters. BEHA staff noted a dark oily stain (e.g. hydraulic fluid) on the filter, which suggests a possible leak/malfunction of the pneumatic system (see Picture 10). The filter was also coated with

Univalent Filter Stained With Oily Substance

1. To maximize air exchange, the BEHA recommends that both supply and exhaust ventilation operate continuously during periods of school occupancy.
2. Examine univent in classroom 10 for proper function and repair if necessary.
3. Consider having the systems balanced by an HVAC engineering firm every five years in accordance with SMACNA guidelines.
4. Remove all obstructions from univents and mechanical exhaust vents to facilitate airflow.
5. For buildings in New England, periods of low relative humidity during the winter are often unavoidable. Therefore, scrupulous cleaning practices should be adopted to minimize common indoor air contaminants whose irritant effects can be enhanced when the relative humidity is low. To control for dusts, a HEPA filter equipped vacuum cleaner in conjunction with wet wiping of all surfaces is recommended.

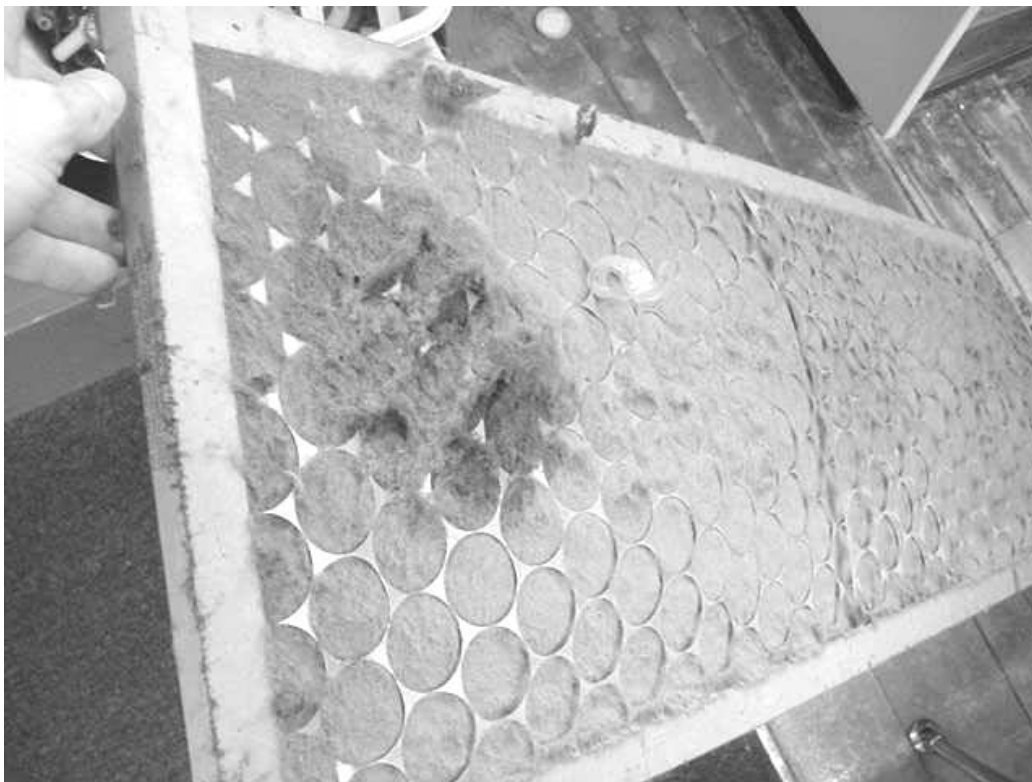
Picture 11

dirt/dust and accumulated material (see Picture 11). A debris-saturated filter can obstruct airflow and may serve as a reservoir of particulates that can be re-aerosolized and distributed to occupied areas via the ventilation system.

Dirty Classroom Univalent Filter

9. Replace missing ceiling tile in all-purpose room. Consider reattaching physical therapy equipment on an as-needed basis.
10. Change univent filters as per the manufacturer's instructions or more frequently if needed.

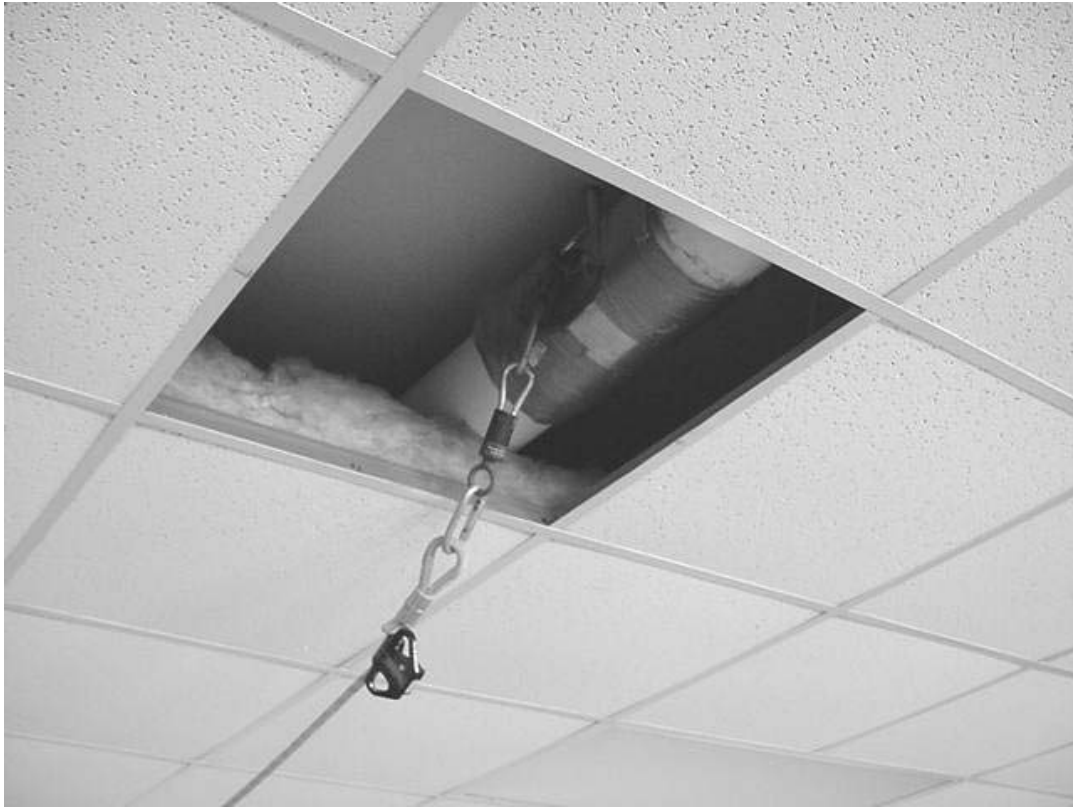
Picture 12

A missing ceiling tile with exposed fiberglass was observed in the all-purpose room (see Picture 12). Aerosolized dust, particulates and fiberglass can provide a source of eye, skin and respiratory irritation to certain individuals. In addition, these materials can accumulate on flat surfaces (e.g., desktops, shelving, and carpets) in occupied areas and subsequently be re-aerosolized causing further irritation.

Missing Ceiling Tile and Exposed Fiberglass in All-Purpose Room
